At Load Power Factor Correction Phase 1: Apartments

A Pilot Project to determine the feasibility and economics of small scale "At Load" Power Factor Correction

Richard Ellenbogen, MEE

October 21, 2009

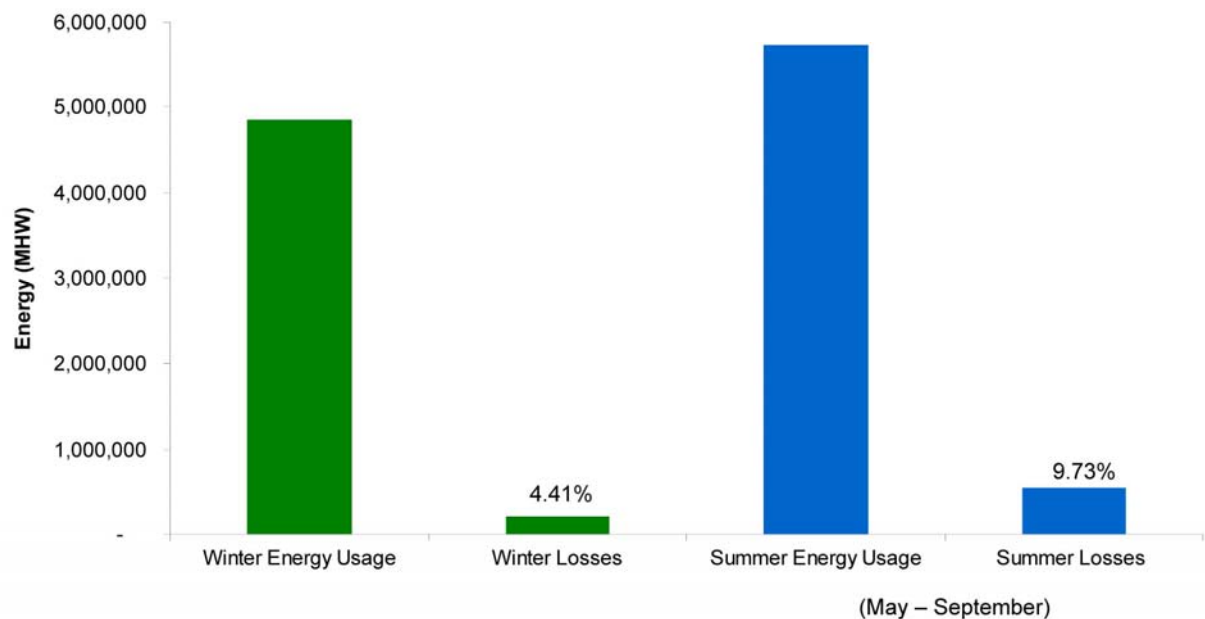
Figure 2: Excerpted from Transmission and distribution Losses. Consolidated Edison. Originally presented July 17, 2008

Figure 2 shows the average losses in summer versus winter and the seasonal net energy usage. It can be seen that losses during the summer months are 2.2 times higher than during the winter months. The higher summertime electric load results in heating of all components of the transmission and distribution system. In addition, there is less ambient cooling of components as a result of the higher ambient air temperatures. More direct sunlight and more hours of daylight result in a far greater solar load. When all of these factors are combined, the result is that the entire system operates at an elevated temperature. As the temperature of

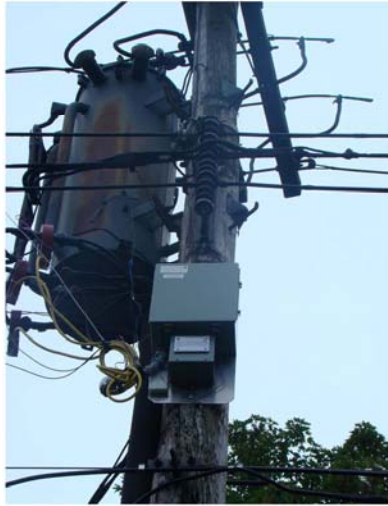
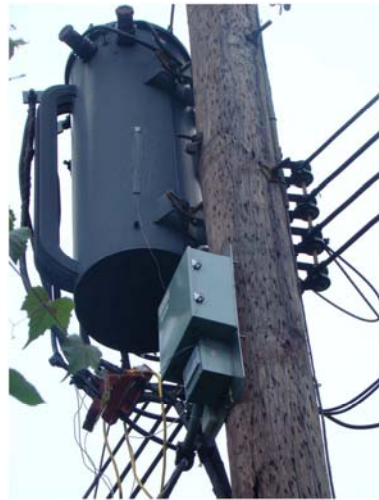
Figure 3: Pole Monitors at Hilltop Terrace. Monitor 10 services one building at Hilltop Terrace and a second building in a different complex. Monitor 11 services five buildings at Hilltop Terrace. The transformer at Monitor 10 is a 75 KVA, 3 phase transformer. The transformer at Monitor 11 is a 150 KVA, 3 phase transformer. Both transformers date to the construction of the complex in 1965.

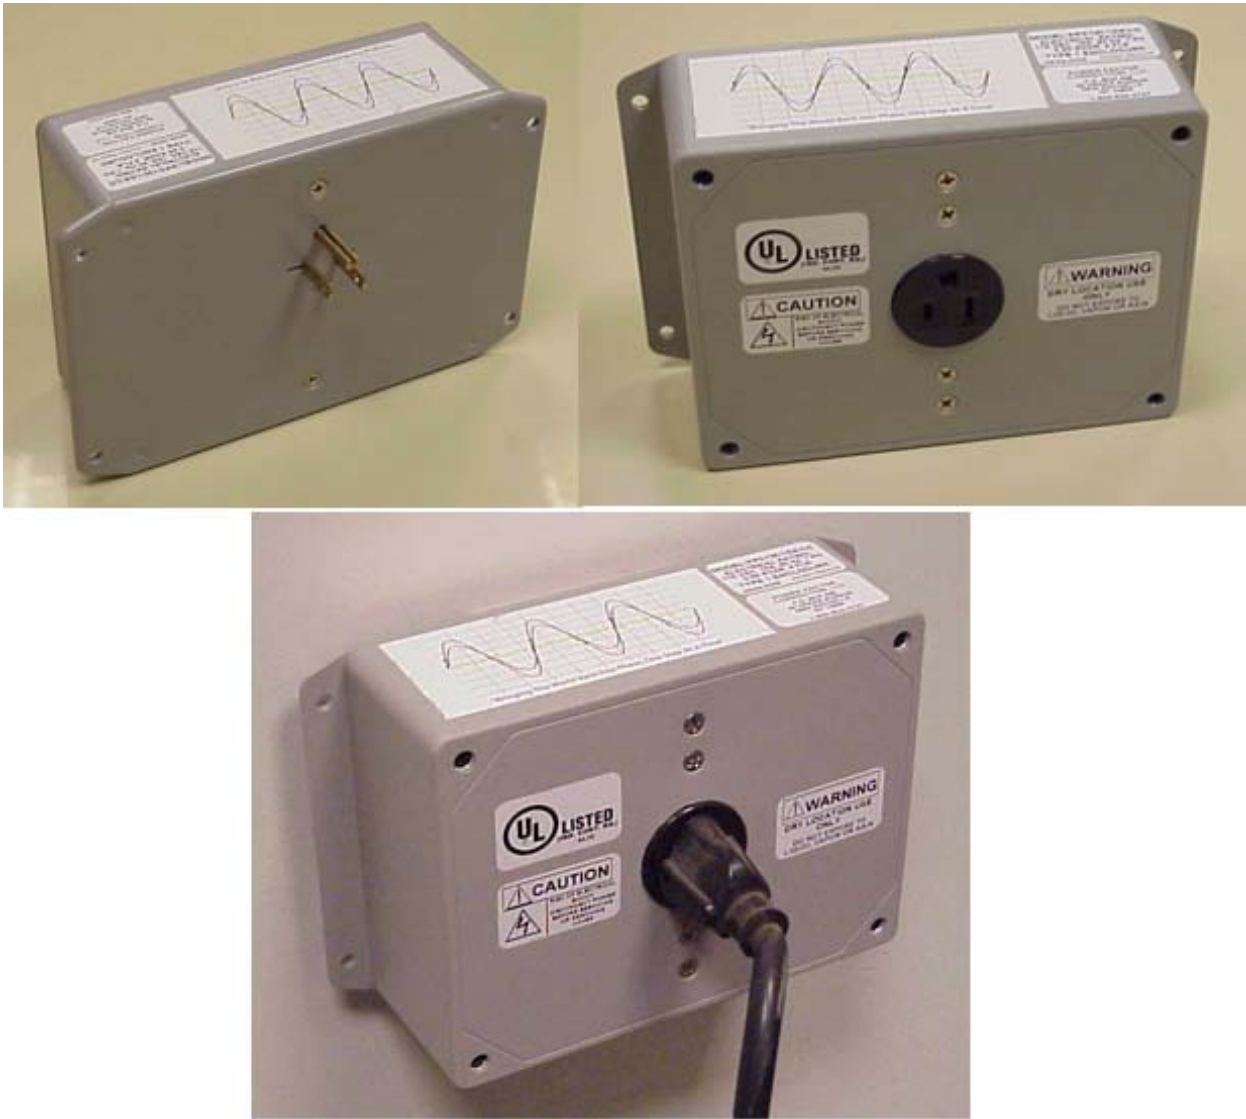
Figure 5: The PLIP[®] Plug In Power factor correction. Power Factor Installation costs are greatly reduced. An unskilled person can install these.

- 7 Device Design :** While devices for power factor correction are readily available for large facilities, that is not the case for the smaller scale application that we are considering here. Labor and other installation costs have to be kept to a minimum in order to make this process viable. In the past, one of the reasons that small scale power factor correction has not been applied is installation cost. The bulk of that cost is in labor. After applying for the grant and prior to being approved for the grant, we designed and fabricated devices that could be installed by a non-technical person. No electrician is needed. A patent was filed on these devices, called PLIP’s[®], in November, 2008. PLIP[®] is an acronym for “Plug In Power Factor Correction”. Figure 5 is a photo of a PLIP[®].
